# Manhole Inspection Summary

## Manhole # S31AA1015MH

Insp Date: **5/21/07 1:35 PM**

**Location** Address: **SAN MARTIN DR**

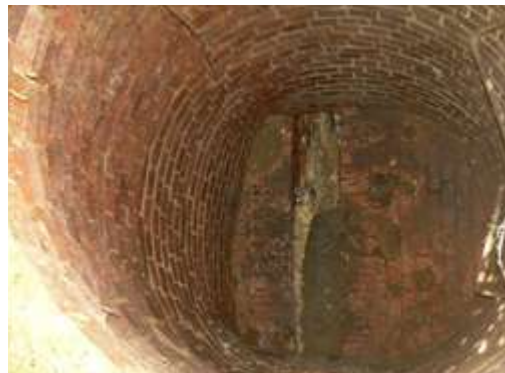
Top View

**Bench** ☒ Exists Material: **Brick** ☐ Parged ☒ **Debris** (not Condition related)

Condition: ☐ Sound ☐ Cracked ☐ Root Intrusion ☐ Deteriorated ☐ Leaks ☒ **Debris**

Bench and Channel debris.

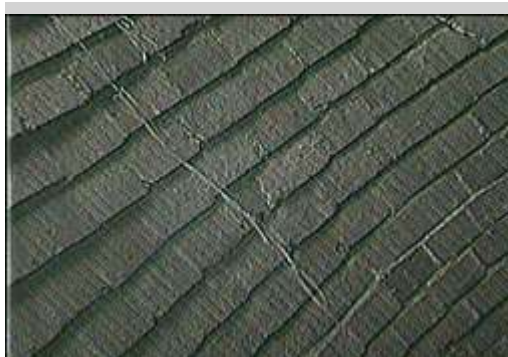
Defect

Condition: ☐ Sound ☐ Cracked ☒ **Root Intrusion** ☐ Loose Brick ☐ Deteriorated

Infiltration: ☐ None ☒ **Joint** ☐ Cracks ☐ Mortar ☒ **Roots** ☒ **Wall**

Corbel root intrusion and infiltration.

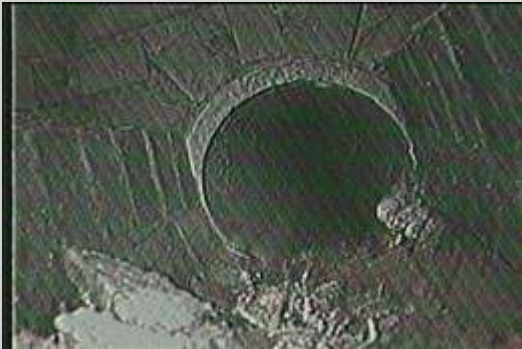
## 10 in. Circular Gravity Sewer Pipe Out @ 12 O'Clock

Deposits: ☐ None ☐ Mud ☐ Sludge ☐ Debris ☒ **Grease**

Silt Depth: **0** (in.) Deposits Extent: **Light**

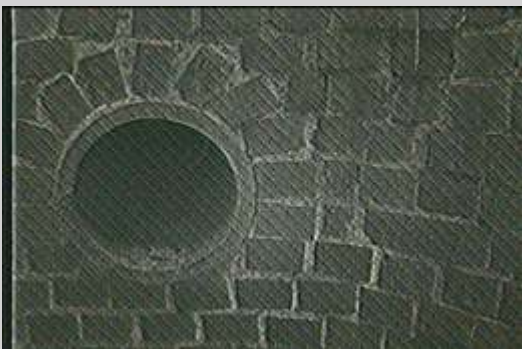
## 10 in. Circular Gravity Sewer Pipe In @ 6 O'Clock

Deposits: ☐ None ☐ Mud ☐ Sludge ☐ Debris ☒ **Grease**

Silt Depth: **0** (in.) Deposits Extent: **Light**

Infiltration: **Evidence** Pipe Seal Cond: **Unknown**

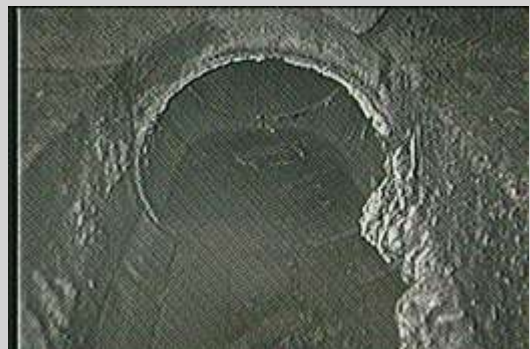
## Drop In @ 6 O'Clock

Drop: **Outside** Rod and Bar

Drop Condition: **Open**
